**Performance Review of Keyless Locking Assemblies in a High Capacity Slope Belt
Application**

Mine site managers reported occurrences of locking assembly bolt failures on the Enlow Fork Coal Mine's slope belt conveyor. The observations were made after a number of years of operation and raised questions as to the status of the assemblies in operation. These questions prompted a detailed review of the situation by independent consultants. Using operational history of the conveyor and confirmation of belt loads by static and dynamic methods, a locking assembly fatigue curve was created to suggest expected service life. From this work suggestions were made to modify the pulley assemblies for extended service life.

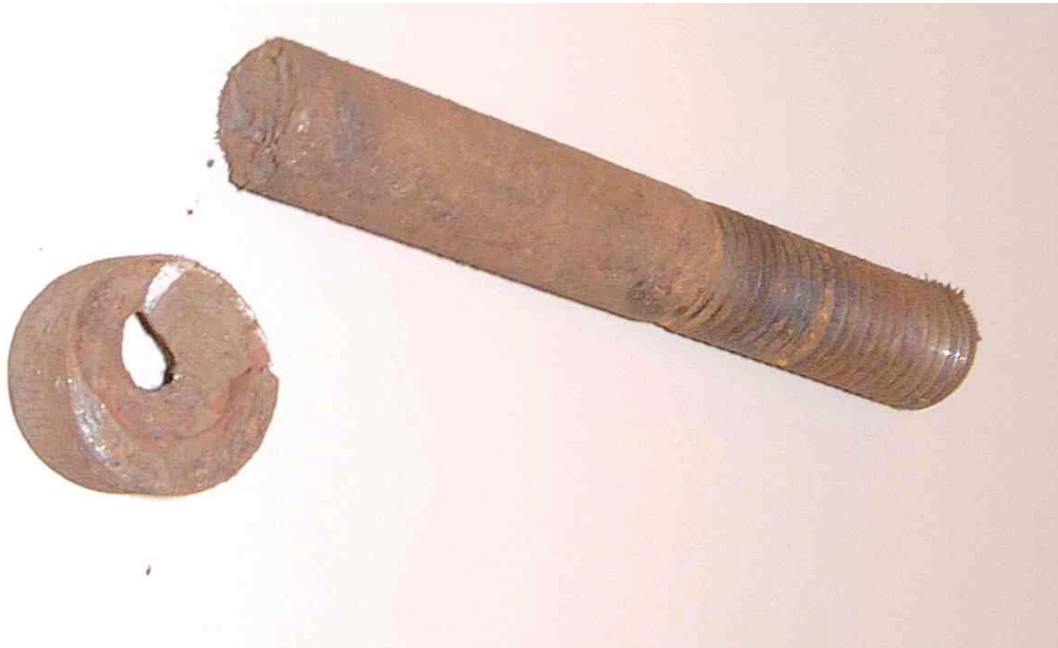
Figure 2: Locking assembly bolt fatigue failure.

Two problems with the low tension pulley assemblies have been encountered. One problem has been premature bearing failures in the P3 position. The second problem has been locking assembly bolt breakage and shaft fretting under the locking assemblies in pulley positions P3 and P5. The team's primary focus was on the locking assembly problems, although the investigation did provide information useful in the bearing analysis. Figure 2 shows a bolt that failed in one of the low tension pulleys. Inspection indicates it to be a fatigue failure initiating in the transition area from head to shank. Figure 3 shows the shaft surface fretting in the area where it contacts the locking assembly.

Of the two reported failures, one can be considered premature due to installation discrepancies. When disassembled, it was observed that the locking assembly had been mounted over 30 mm (1.18 in) off center with the shaft lands and pulley hub. This offset caused a significant portion of the inner contact ring to have no shaft contact and reduced the hub contact with the outer ring the same amount. By all indications the second pulley was properly assembled, and since the failure's occurred at a load level less than the rated value further investigation is warranted.

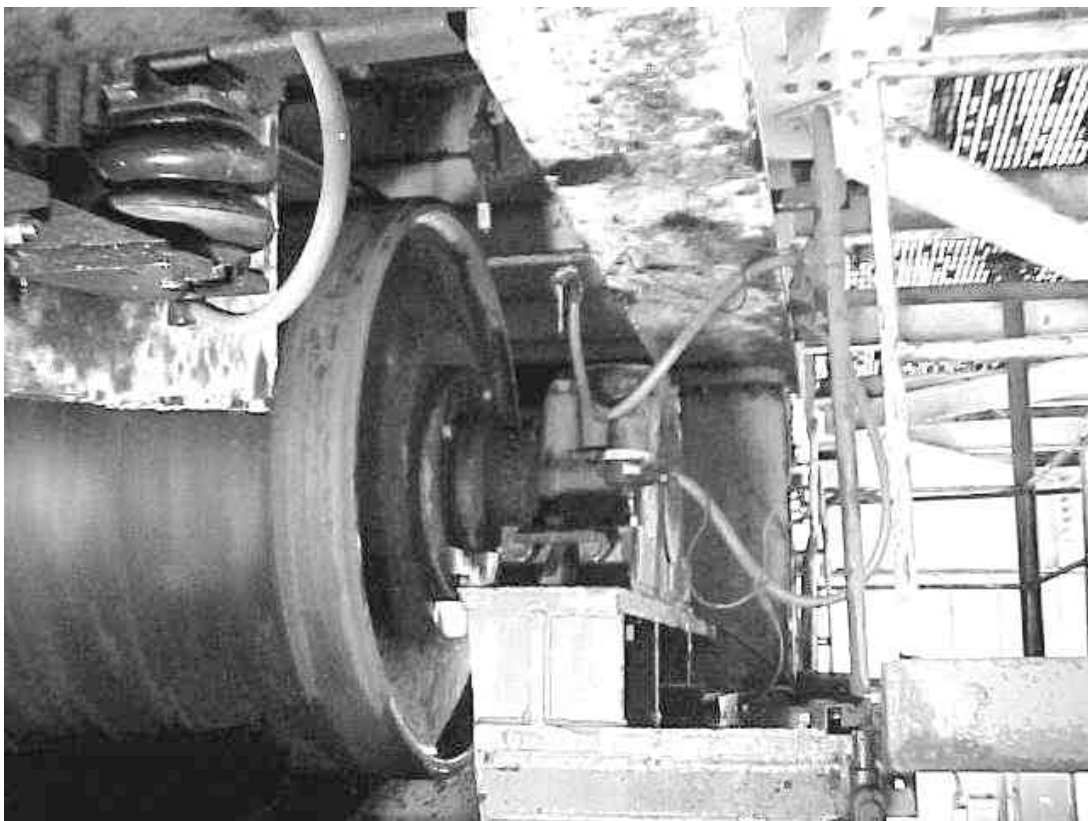
Figure 4: Low tension pulley in P3 position.

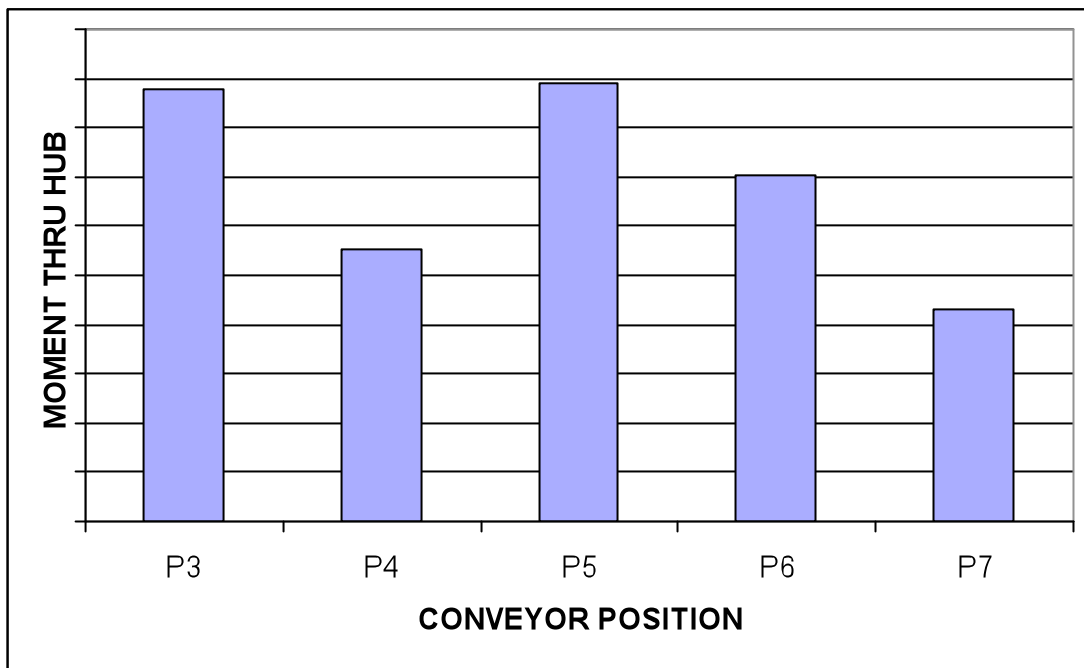
Figure 5: Bending moment through the locking assembly by conveyor position.

produced bending moments through the locking assembly as shown in figure 5. Site maintenance records showed that problems had occurred at P3 and P5 positions, which correspond with the positions of highest bending moment in figure 5.

For a non-drive pulley application, the primary locking assembly design load is the bending moment transmitted through each locking assembly. Using belt loads calculated earlier, each of the low tension pulleys were analyzed using finite element analysis (FEA). Results of the FEA

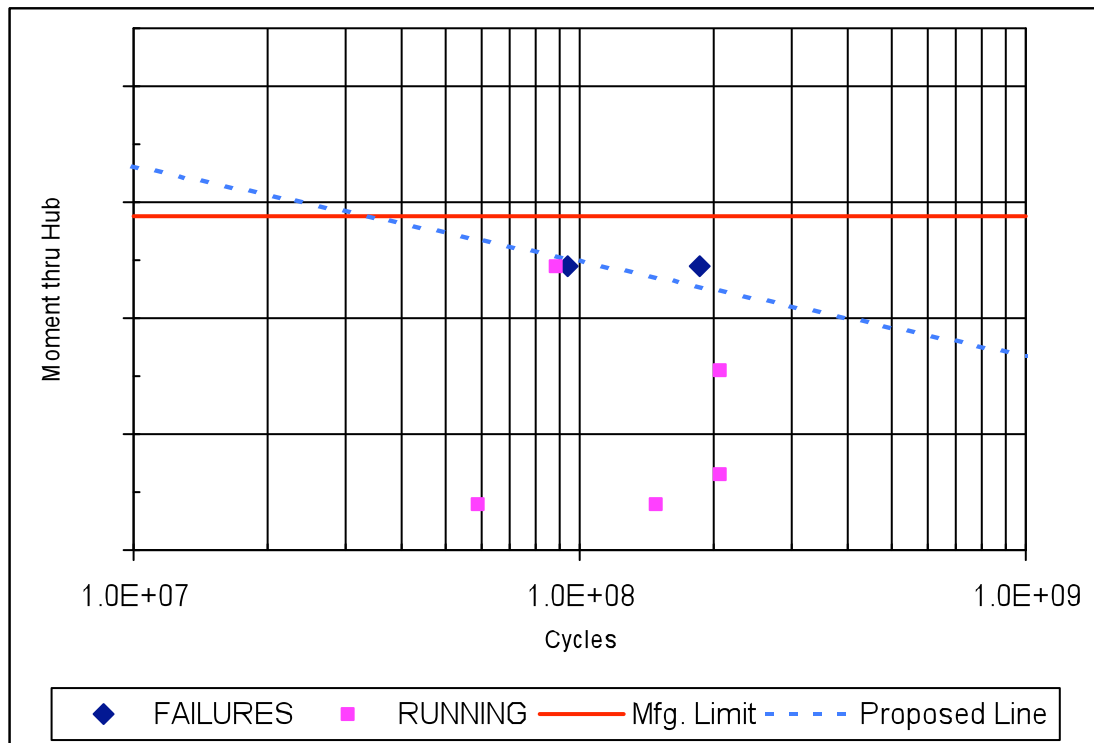
The graph in figure 6 is a S-N type curve comparing actual field data with the locking assemblies load rating. Individual points on the graph are results observed in service. Points designated “RUNNING” represent locking assemblies in use that have not shown signs of failure and those removed from service for unrelated reasons. Points designated “FAILURES” represent locking assemblies where bolt breakage and fretage have occurred. The two design lines shown represent a manufacturer’s locking assembly load rating and a proposed design line based on fatigue data.

Figure 6: Locking assembly S-N curve.

The manufacturers locking assembly load rating presented has been reduced 10 percent from normally published values due to original pulley design specifications. The original design called for locking assembly bolt torques to be reduced by 10 percent. When using moderately reduced bolt torques, some locking assembly manufacturers recommend lowering published load ratings by the same percentage. They also qualify this as an oversimplification of the situation, since the relationship between bolt torque and load rating is not linear. This simplification is used because the relationship is nearly linear for a moderate reduction in bolt torque. The authors recommend consultation with the locking assembly manufacturer before attempting this modification.

The suggested safe running line shown on figure 6 is an estimate of the fatigue life expectations of the locking assembly bolts in this application. The bolts used in locking assemblies are typically made from heat treated carbon alloy steel consistent with SAE grade 8 specifications. Since this applications life expectations are greater than 10^8 cycles the bolts high cycle fatigue properties were of primary concern. For this reason only the elastic strain portion of the S-N curve is presented. It also should be noted that the line is sloped, which goes against the commonly accepted practice of considering 10^7 cycles as a transition to infinite life. A number of works referenced discuss this concept, and its acceptance appears to be increasing. One authors experience and research in high cycle weld fatigue supports the theory. The proposed design line uses a material fatigue strength exponent of -0.08 for the slope, which is then empirically superimposed over the field data.
