PPI'S REWORK SERVICES CAN SAVE YOU TIME AND MONEY

LAGGING WEAR INDICATOR

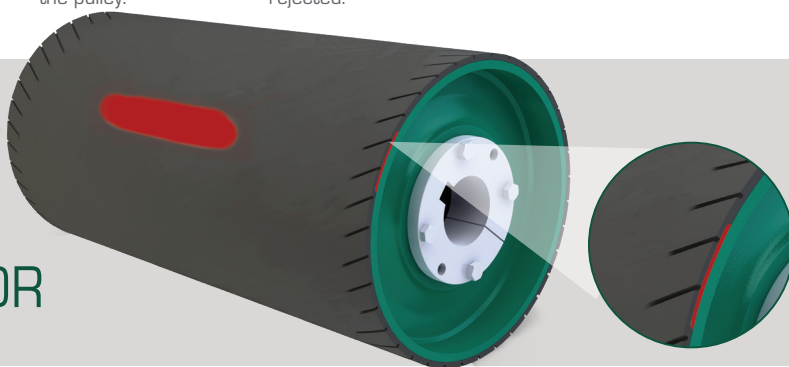
The Lagging Wear Indicator consists of a 3 inch wide strip of green rubber embedded in the bottom layer of lagging. When this green wear indicator strip becomes visible on the face of the pulley, it alerts maintenance that the lagging is nearing the end of its service life. Standard on 24" diameter and above, optional for smaller.

*This product is only available in the US and Canada.
The pulley displayed is representing worn lagging with a visible indicator warning.*

PPI's new patent pending Lagging Wear Indicator feature lets you know when pulley lagging is at the end of its wear life.
